**Flood Control Project Maintenance  
Levee Inspections**  
**LMA District Cover Sheet**  
**Spring 2019 Levee Inspection Results**

**Reclamation District No. 0369 Libby McNeil**

Waterway			Bank	Unit Miles
Unit No. 01 Sacramento River			Left	0.78
	Spring (March - May)	Summer (June - August)	(September - November) Fall	Winter (December - February)
Unit Maintenance Rating (Fall Only)				
Date of Inspection	3/15/2019 - 3/15/2019			
DWR Inspector	David Julian			
Accompanied By

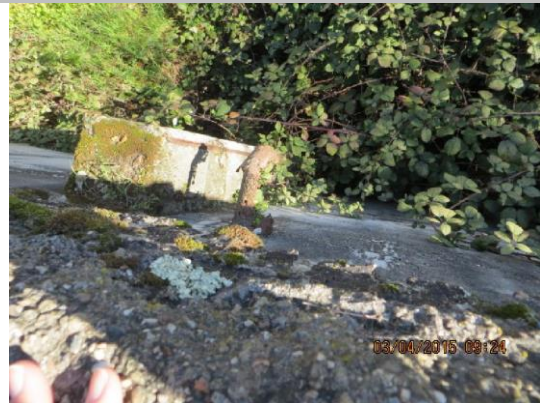
Photo 1 of 3 : UCIP\_SP\_2019\_50105\_73165.jpg

LM Start	0.04	Rating **	M	Issue No.	30
LM End	0.04	Issue Type +	En	Location *	
Category	Supplemental			GPS Latitude/Longitude	
				Start	End
Item	DWR UCIP Field Study			38.258434 °	38.258434 °
				-121.517283 °	-121.517283 °
DWR ID	18971

Comment Code					
Inspector Comment					
FS_ID:50105 DS_ID:18971 EP_NO: 8555 Repair Type: Non-Urgent Crossing Status: Found UCIP Comments: 03/04/2015 Pipe corroded through on LS at retaining wall. May not go all the way through the levee. Appears abandoned and if so should be done so properly. FIELD_STRUCT_DESC: *ABANDONED* 2 of 2: 4-inch steel pipe of an unknown purpose through the levee, 4 feet below the crown. Pipe visible on the landside (LS) at a retaining wall. (Retention of a 6-inch pipe and a 4-inch pipe through the levee authorized under Automatic Board Order (ABO) issued as Permit No. 8555, 1973 - Jordon Investment Company, care of Walter E. Herman). [Additional Reference(s): DWR Levee Log, 2005. USACE Sacramento O&M Manual 111, May 1959, (RM 27.87), O&M Manual misidentifies this location as RM 28.87]. FS Date: 3/4/2015 4:11:00 PM

Pipe visible on retaining wall at LS toe.

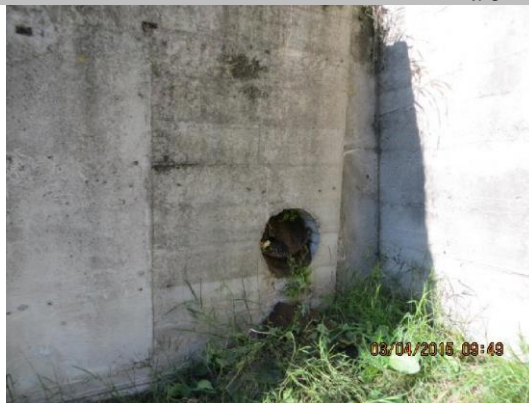
Photo 1 of 3 : UCIP\_SP\_2019\_43811\_73162.jpg

LM Start	0.05	Rating **	M	Issue No.	31
LM End	0.05	Issue Type +	En	Location *	
Category	Supplemental			GPS Latitude/Longitude	
				Start	End
Item	DWR UCIP Field Study			38.258347 °	38.258347 °
				-121.517169 °	-121.517169 °
DWR ID	18970				
Comment Code					
Inspector Comment					
FS_ID:43811 DS_ID:18970 EP_NO: N/A Repair Type: Non-Urgent Crossing Status: Found UCIP Comments: 03/04/2015 Pipe appears abandoned and is filled with soil. Appears abandoned and if so should be done so properly. FIELD_STRUCT_DESC: *ABANDONED* 8-inch steel gravity drainage pipe through the levee, 8 feet below the crown. Hole in the concrete retaining wall on the landside (LS) slope, measures 10 inches in diameter. [Additional Reference(s): DWR Levee Log, 2005]. FS Date: 3/4/2015 4:41:00 PM

10-inch hole in concrete retaining wall likely for this pipe. Visible on LS toe. Portion of pipe visible.

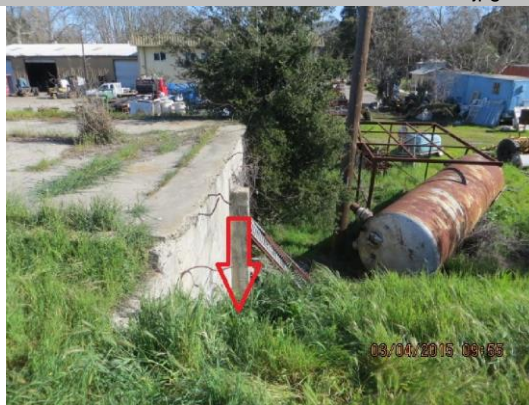
Photo 2 of 3 : UCIP\_SP\_2019\_43811\_73161.jpg

10-inch hole in concrete retaining wall likely for this pipe. Visible on LS toe.

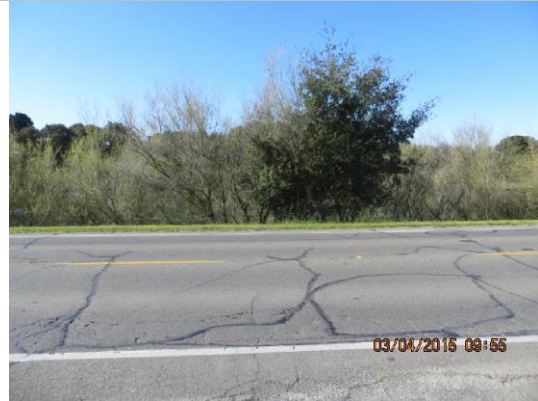
Photo 3 of 3 : UCIP\_SP\_2019\_43811\_73160.jpg

View of WS. No pipe found.

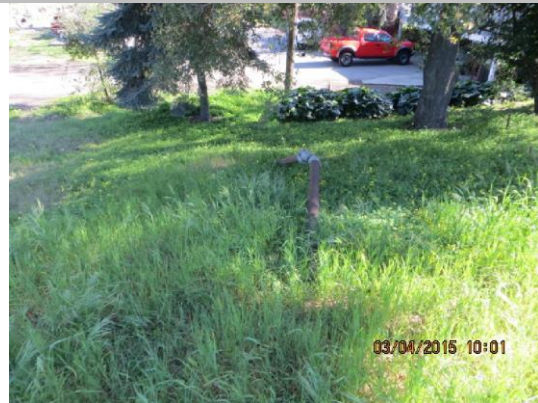
Photo 1 of 3 : UCIP\_SP\_2019\_53396\_73331.jpg

LM Start	0.09	Rating **	U	Issue No.	32
LM End	0.09	Issue Type +	En	Location *	
Category	Supplemental			GPS Latitude/Longitude	
				Start	End
Item	DWR UCIP Field Study			38.257953 °	38.257953 °
				-121.516613 °	-121.516613 °
DWR ID	25084

Comment Code					
Inspector Comment					
FS_ID:53396 DS_ID:25084 EP_NO: N/A Repair Type: Urgent Crossing Status: Found UCIP Comments: 07/12/2018 Pipe shows more signs of corrosion. Unable to find pipe on WS. (O.Yakimov-DWR UCIP)06/01/2016 Same as last inspection. (K. Fazel - UCIP)03/04/2015 Severe corrosion and holes visible in pipe on LS shoulder. Pipe appears abandoned and should be done so properly. (W. Wyle - FPIIB) FIELD_STRUCT_DESC: *ABANDONED* 4-inch steel pipe of an unknown purpose through the levee, 1 foot below the crown. Pipe visible on the landside (LS) slope just in front of the gate on the LS shoulder. [Additional Reference(s): USACE Sacramento O&M Manual 111, May 1959, (RM 27.87), O&M Manual misidentifies this location as RM 28.87]. FS Date: 7/1/2018

Pipe visible on LS slope.

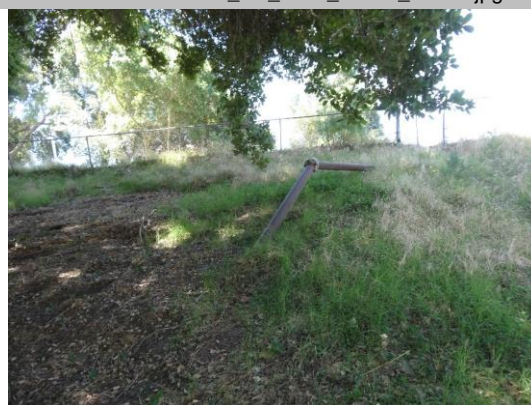
Photo 3 of 3 : UCIP\_SP\_2019\_53396\_75199.jpg

LS slope: view of pipe.

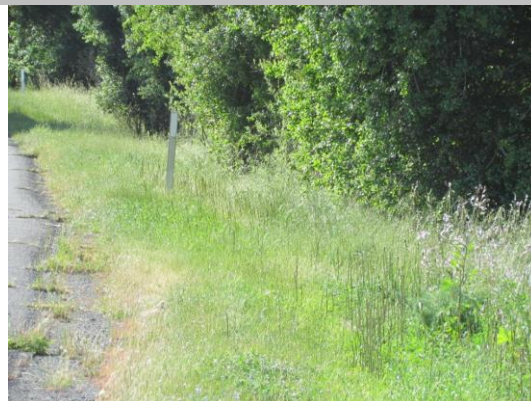
Photo 1 of 1 : SP\_2019\_RD0369\_207\_9\_20190311\_00003.jpg

LM Start	0.25	Rating **	A	Issue No.	9
LM End	0.57	Issue Type +	Ma	Location *	WS
Category	Earthen Levee			GPS Latitude/Longitude	
				Start	End
Item	Vegetation			38.256372 °	38.252597 °
				-121.514504 °	-121.511130 °
DWR ID	DWR_RD0369_01_s_2017_9				
Comment Code					
V2 : Remove the wild growth other than native grasses from the levee slopes.					
Inspector Comment					
Spray the weed growth along the waterside slope to 20' from crown.

Looking downstream from the waterside shoulder.

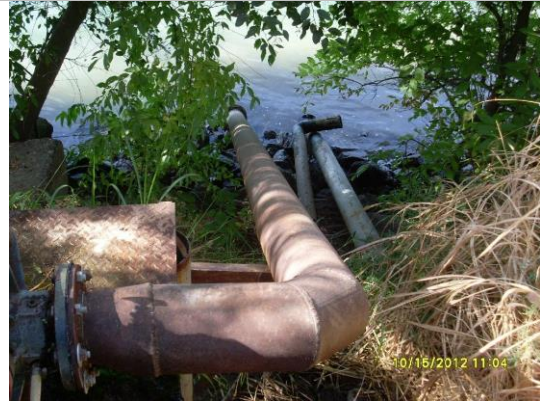
Photo 3 of 3 : UCIP\_SP\_2019\_43814\_10459.jpg

Comment Code						
Inspector Comment						
FS_ID:43814 DS_ID:18972 EP_NO: 11117 Repair Type: Non-Urgent Crossing Status: Found UCIP Comments: 10/15/2012 Siphon breaker on LS slope needs protection. Water is leaking from pump station. Abandoned concrete structure found on WS. 10-inch abandoned pipe found on WS. Should be removed. 6-inch abandoned pipe found on WS. Should be removed. FIELD_STRUCT_DESC: *ABANDONED* 10-inch steel irrigation discharge pipe through the levee, 4.5 feet below the crown. Pump and gate valve on the waterside (WS) shoulder. Siphon breaker on the landside (LS) slope. 6-inch abandoned pipe also found on the WS. (Retention of a 10-inch pipe through the levee, 4.5 feet below the crown, and a pump in a pump house on the WS slope authorized under Automatic Board Order (ABO) issued as Permit No. 11117, 1975 - Erma E. Locke, et al.). [Additional Reference(s): DWR Levee Log, 2005. USACE Sacramento O&M Manual 111, May 1959, (RM 27.63), referenced as invert elevation 3.8 feet below the crown]. FS Date: 10/15/2012 4:11:00 PM

Waterside view: overview of active pipe and two abandoned pipes.

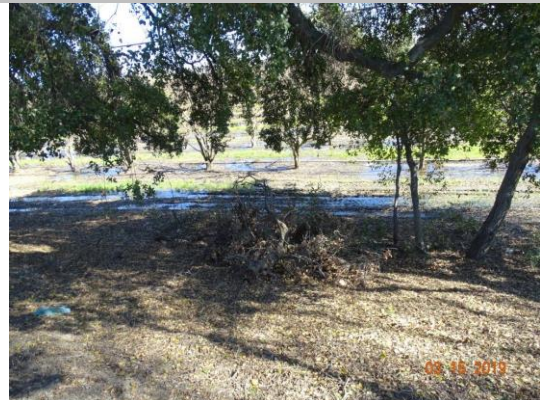
Photo 1 of 1 : SP\_2019\_RD0369\_207\_11\_20190320\_00027.jpg

LM Start	0.35	Rating **	M	Issue No.	11
LM End	0.35	Issue Type +	Ma	Location *	LS
Category	Earthen Levee			GPS Latitude/Longitude	
				Start	End
Item	Encroachments			38.255250 °	38.255250 °
				-121.513207 °	-121.513207 °
DWR ID	DWR_RD0369_01_s_2019_11				
Comment Code					
TR : Tree or limb					
Inspector Comment					
Remove fallen tree limbs from the landside slope.

View of fallen limbs on the landside slope (Spring 2019).

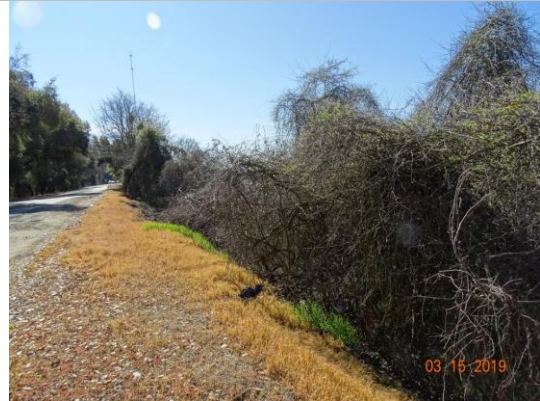
Photo 1 of 1 : SP\_2019\_RD0369\_207\_24\_20190320\_00029.jpg

LM Start	0.41	Rating **	U	Issue No.	24
LM End	0.53	Issue Type +	Ma	Location *	WS
Category	Earthen Levee			GPS Latitude/Longitude	
				Start	End
Item	Trim / Thin Trees			38.254607 °	38.253073 °
				-121.512657 °	-121.511388 °
DWR ID	DWR_RD0369_01_s_2019_24				
Comment Code					
T1 : Trim trees to at least five feet above ground level.					
Inspector Comment					
Trim trees to allow visibility down the waterside slope.

View looking downstream at thick trees on the waterside slope (Spring 2019).

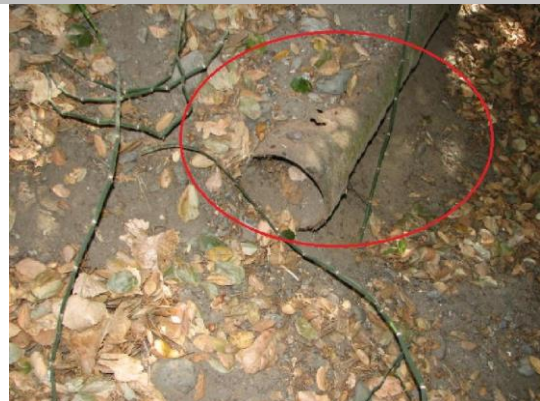
Photo 1 of 2 : UCIP\_SP\_2019\_43815\_73301.jpg

LM Start	0.50	Rating **	M	Issue No.	34
LM End	0.50	Issue Type +	En	Location *	
Category	Supplemental			GPS Latitude/Longitude	
				Start	End
Item	DWR UCIP Field Study			38.253468 °	38.253468 °
				-121.511654 °	-121.511654 °
DWR ID	18981				
Comment Code					
Inspector Comment					
FS_ID:43815 DS_ID:18981 EP_NO: N/A Repair Type: Non-Urgent Crossing Status: Indicator Found UCIP Comments: Found abandoned pipe laying on WS levee slope. Pipe purpose and status should be determined. further investigation required. FIELD_STRUCT_DESC: 8-inch steel pipe of an unknown purpose running parallel to the levee crown on the waterside (WS) slope, 4.5 feet below the crown. This pipe was field discovered. FS Date: 3/4/2015

Pipe visible on WS slope running parallel to crown.

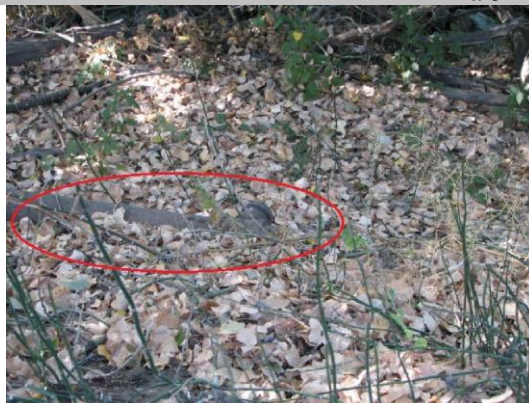
Photo 2 of 2 : UCIP\_SP\_2019\_43815\_73300.jpg

LM Start	0.50	Rating **	M	Issue No.	34 (cont)	
LM End	0.50	Issue Type +	En	Location *		
Category	Supplemental			GPS Latitude/Longitude		
				Start	End	
Item	DWR UCIP Field Study			38.253468 °	38.253468 °	
				-121.511654 °	-121.511654 °	
DWR ID	18981					
Comment Code						
Inspector Comment						
FS_ID:43815						
DS_ID:18981						
EP_NO: N/A						
Repair Type: Non-Urgent						
Crossing Status: Indicator Found						
UCIP Comments: Found abandoned pipe laying on WS levee slope.						
Pipe purpose and status should be determined. further investigation required.						
FIELD_STRUCT_DESC: 8-inch steel pipe of an unknown purpose running parallel to the levee crown on the waterside (WS) slope, 4.5 feet below the crown. This pipe was field discovered.						
FS Date: 3/4/2015

Pipe on WS slope running parallel to levee crown.

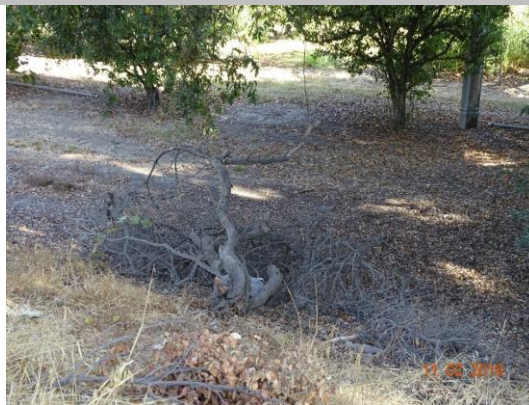
Photo 1 of 1 : SP\_2019\_RD0369\_207\_19\_20190311\_00008.jpg

LM Start	0.52	Rating **	M	Issue No.	19
LM End	0.52	Issue Type +	Ma	Location *	LS
Category	Earthen Levee			GPS Latitude/Longitude	
				Start	End
Item	Encroachments			38.253273 °	38.253273 °
				-121.511505 °	-121.511505 °
DWR ID	DWR_RD0369_01_f_2018_19				
Comment Code					
TR : Tree or limb					
Inspector Comment					
Remove tree limb from the landside slope.

View of tree limb on the land sideslope (November 2018).

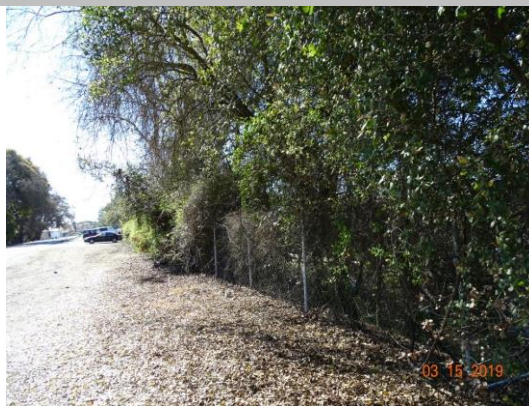
Photo 1 of 1 : SP\_2019\_RD0369\_207\_25\_20190320\_00031.jpg

View looking downstream at chainlink fence on the waterside slope (Spring 2019).

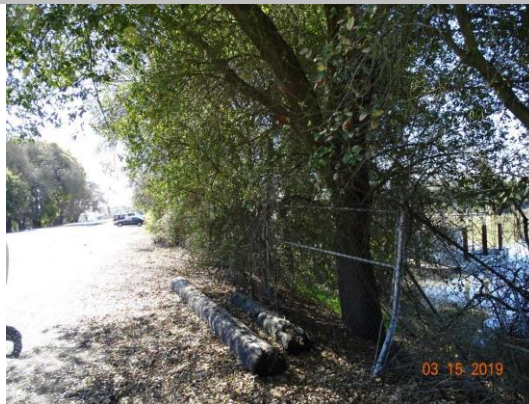
Photo 1 of 1 : SP\_2019\_RD0369\_207\_26\_20190320\_00030.jpg

LM Start	0.57	Rating **	M	Issue No.	26
LM End	0.60	Issue Type +	Ma	Location *	WS
Category	Earthen Levee			GPS Latitude/Longitude	
				Start	End
Item	Vegetation			38.252662 °	38.252247 °
				-121.511138 °	-121.510922 °
DWR ID	DWR_RD0369_01_s_2019_26				
Comment Code					
V2 : Remove the wild growth other than native grasses from the levee slopes.					
Inspector Comment					
Vegetation on chainlink fence is blocking view down waterside slope.

View looking downstream at the chainlink on the waterside shoulder and slope (Spring 2019).

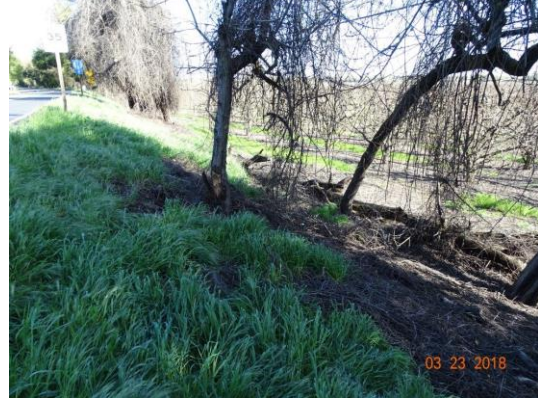
Photo 1 of 1 : SP\_2019\_RD0369\_207\_14\_20190311\_00006.jpg

Remove fallen tree and branches from landside toe.

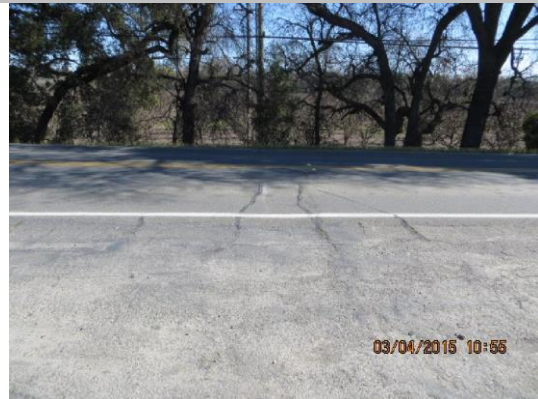
Photo 1 of 3 : UCIP\_SP\_2019\_53524\_73166.jpg

LM Start	0.61	Rating **	U	Issue No.	35
LM End	0.61	Issue Type +	En	Location *	
Category	Supplemental			GPS Latitude/Longitude	
				Start	End
Item	DWR UCIP Field Study			38.252176 °	38.252176 °
				-121.510833 °	-121.510833 °
DWR ID	18977

Comment Code					
Inspector Comment					
FS_ID:53524 DS_ID:18977 EP_NO: 14313 Repair Type: Urgent Crossing Status: Indicator Found UCIP Comments: 07/12/2018 Pipe is covered by thick layer of dry debris on LS. Patch repair along pipe alignment is visible on levee crown. (O.Yakimov-DWR UCIP)06/01/2016 Could not locate pipe. Likely buried next to leach box. Could not find signs of leaking or presence of water or erosion. Pipe may still be leaking but buried. (K. Fazel - UCIP)03/04/2015 Septic line appears to be leaking at LS toe. Erosion of soil and wet soil visible at LS toe. No septic smell accompanied other evidence at site. (W. Wylie - FPIIB) FIELD_STRUCT_DESC: 3 of 3: 2-inch galvanized steel sewer line through the levee, 1 foot below the crown. Metal cutoff wall placed around the pipe near the centerline of the levee. 4-foot by 6-foot concrete box at the landside (LS) toe. Sewer line runs through the property of the district president, Clarence Chu, at ckchu52@comcast.net, (916) 776-1684, and (916) 813-7037. (Plans to install three utility pipes through the levee authorized under Permit No. 14313, 1986 - Frank and Genie Schmiedel. Plans to construct a 59-covered-berth addition to an existing boat dock, extending approximately 60 feet into the Sacramento River, authorized under Permit No. 13783, 1984 - Frank and Genie Schmiedel, mentions the leach line for the septic system). FS Date: 7/12/2018

View at crossing through crown on LS shoulder from WS shoulder.  
Evidence of trench visible at cut in pavement.

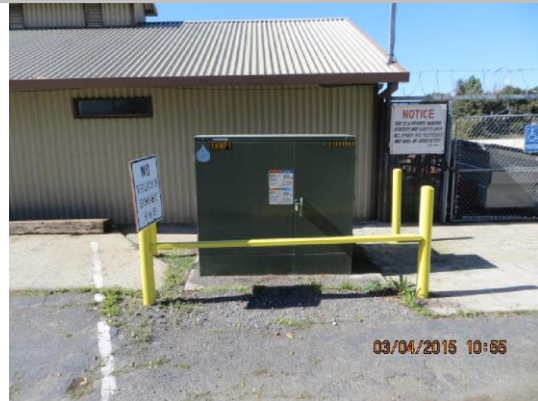
Photo 2 of 3 : UCIP\_SP\_2019\_53524\_73167.jpg

FS\_ID:53524  
DS\_ID:18977  
EP\_NO: 14313  
Repair Type: Urgent  
Crossing Status: Indicator Found  
UCIP Comments: 07/12/2018 Pipe is covered by thick layer of dry debris on LS. Patch repair along pipe alignment is visible on levee crown. (O.Yakimov-DWR UCIP)06/01/2016 Could not locate pipe. Likely buried next to leach box. Could not find signs of leaking or presence of water or erosion. Pipe may still be leaking but buried. (K. Fazel - UCIP)03/04/2015 Septic line appears to be leaking at LS toe. Erosion of soil and wet soil visible at LS toe. No septic smell accompanied other evidence at site. (W. Wylie - FPIIB)  
FIELD\_STRUCT\_DESC: 3 of 3: 2-inch galvanized steel sewer line through the levee, 1 foot below the crown. Metal cutoff wall placed around the pipe near the centerline of the levee. 4-foot by 6-foot concrete box at the landside (LS) toe. Sewer line runs through the property of the district president, Clarence Chu, at ckchu52@comcast.net, (916) 776-1684, and (916) 813-7037. (Plans to install three utility pipes through the levee authorized under Permit No. 14313, 1986 - Frank and Genie Schmiedel. Plans to construct a 59-covered-berth addition to an existing boat dock, extending approximately 60 feet into the Sacramento River, authorized under Permit No. 13783, 1984 - Frank and Genie Schmiedel, mentions the leach line for the septic system).

Waterside view. Unclear if there is a sewer cleanout or other evidence of pipe location on WS shoulder.

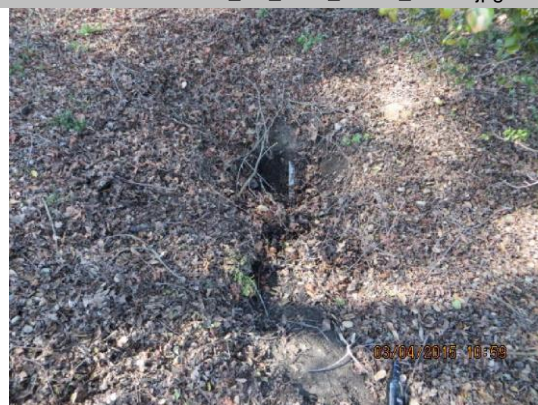
Photo 3 of 3 : UCIP\_SP\_2019\_53524\_73168.jpg

Septic line leaking at LS toe. Erosion of soil at toe visible.

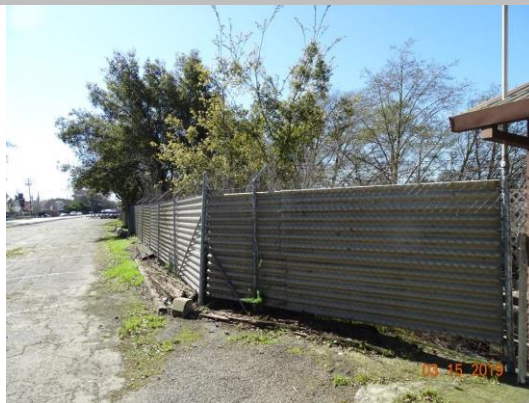
Photo 1 of 1 : SP\_2019\_RD0369\_207\_29\_20190320\_00032.jpg

View of fence on the waterside shoulder (Spring 2019).

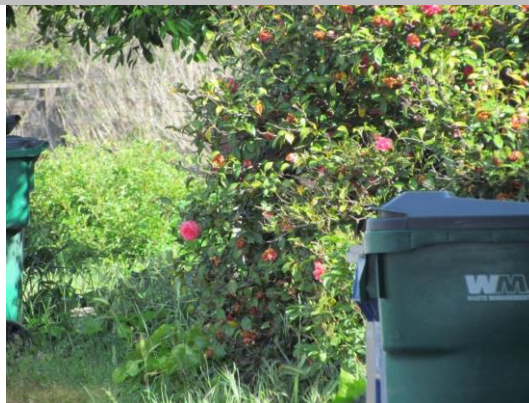
Photo 2 of 2 : SP\_2019\_RD0369\_207\_8\_20190311\_00002.jpg

Looking upstream from levee mile 0.77 to levee mile 0.75 levee slope blocked by vegetation typical view of growth along this section.
